# Memo

Re: Closed Burger Station Inspections 3/25-26/1998 you requested. CC: Ed Malter, Pretreatment Inspectors, Food Inspection(Health)

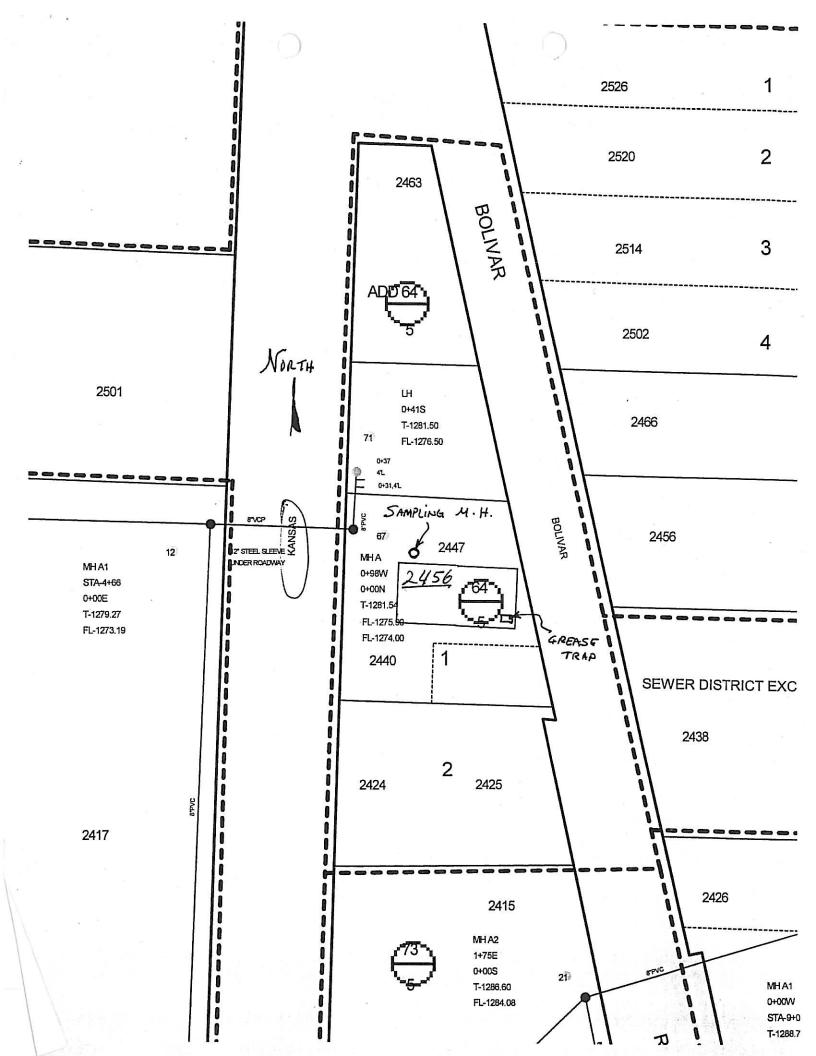
Closed. Sampling manhole present, holes near bottom with rocks and dirt protruding in, not concreted in, no apparent seal between wall and floor, invert shelves full of dirt, no ram-nek visible under ring and lid casting. Pipe has been sawed out to allow sampling. No grease noticeable in sampling manhole. No outside grease trap. Building was locked and all fixtures removed. By looking through the window it appears to have a 20(?) pound grease trap above the floor where the 3-vat sink used to be. Had a Neenah type locking lid casting.
